2001 Annual Monitoring Report

KING COUNTY AGRICULTURAL DRAINAGE ASSISTANCE PROGRAM

June 2002

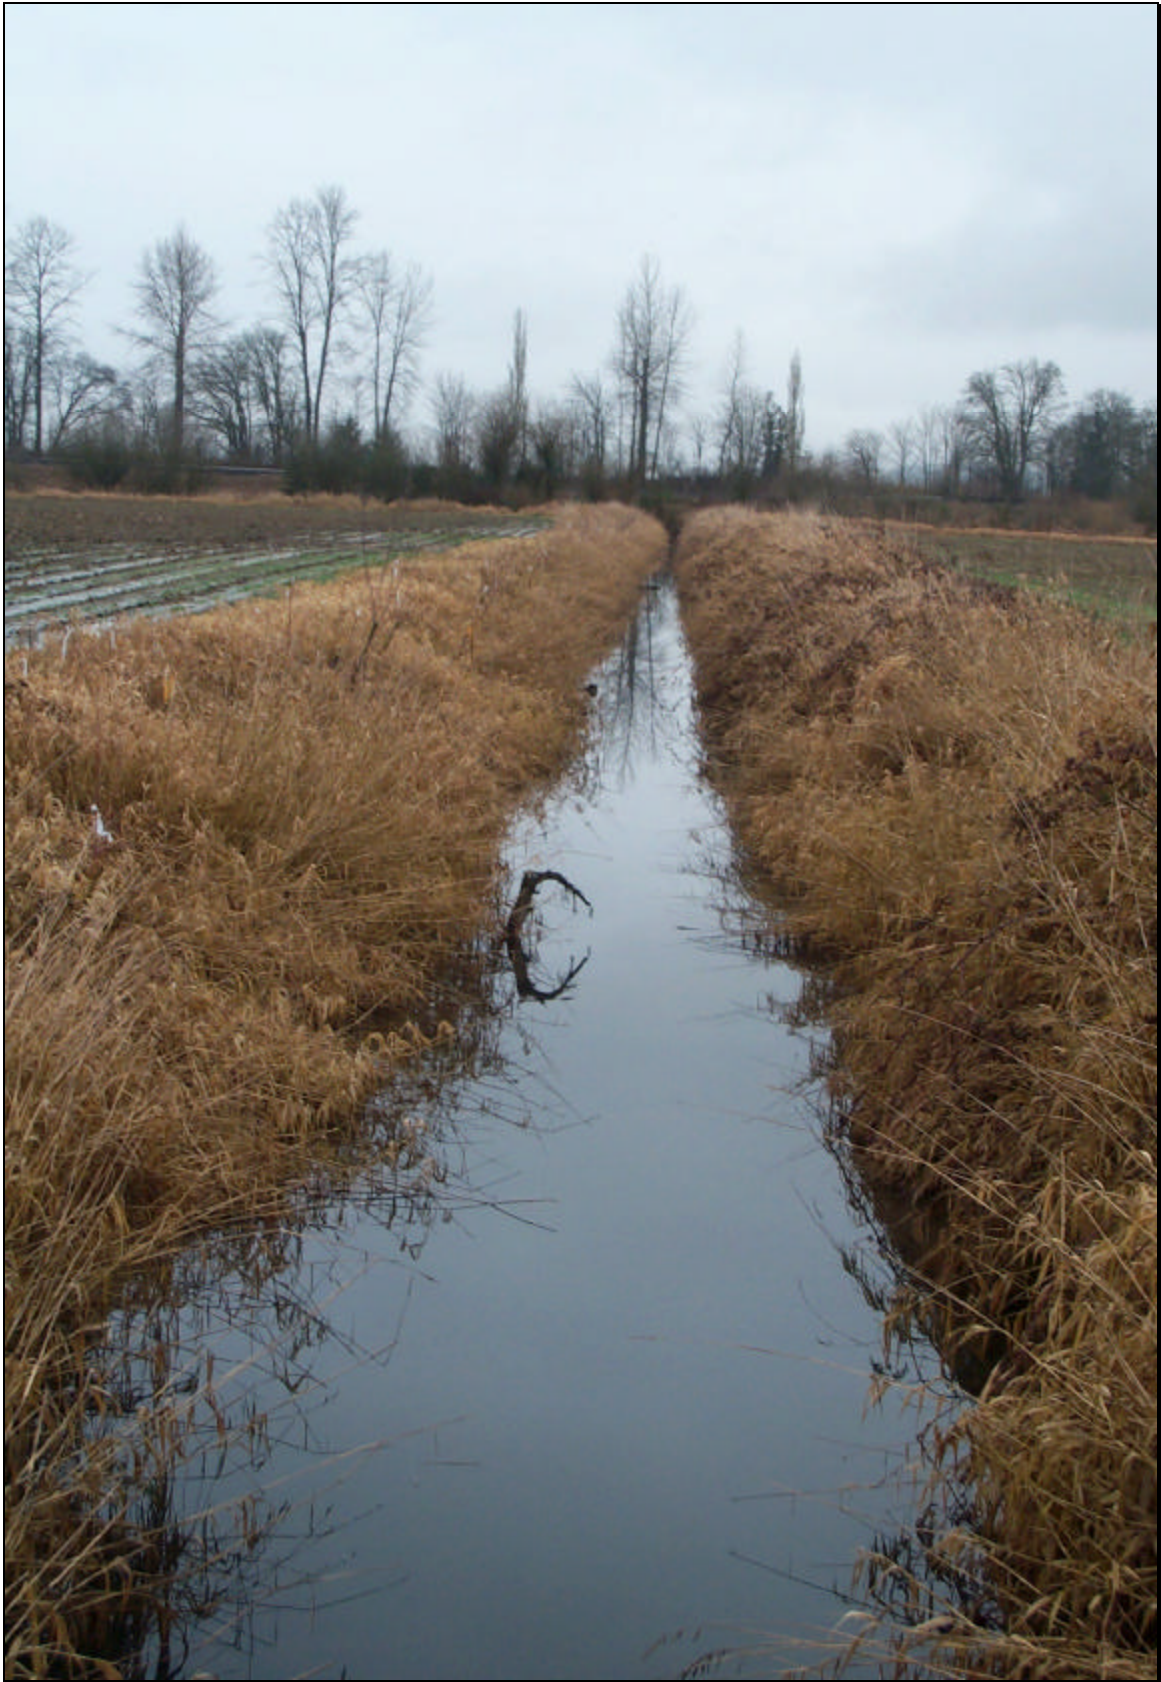
CHERRY VALLEY TRIBUTARY, WINTER 2001

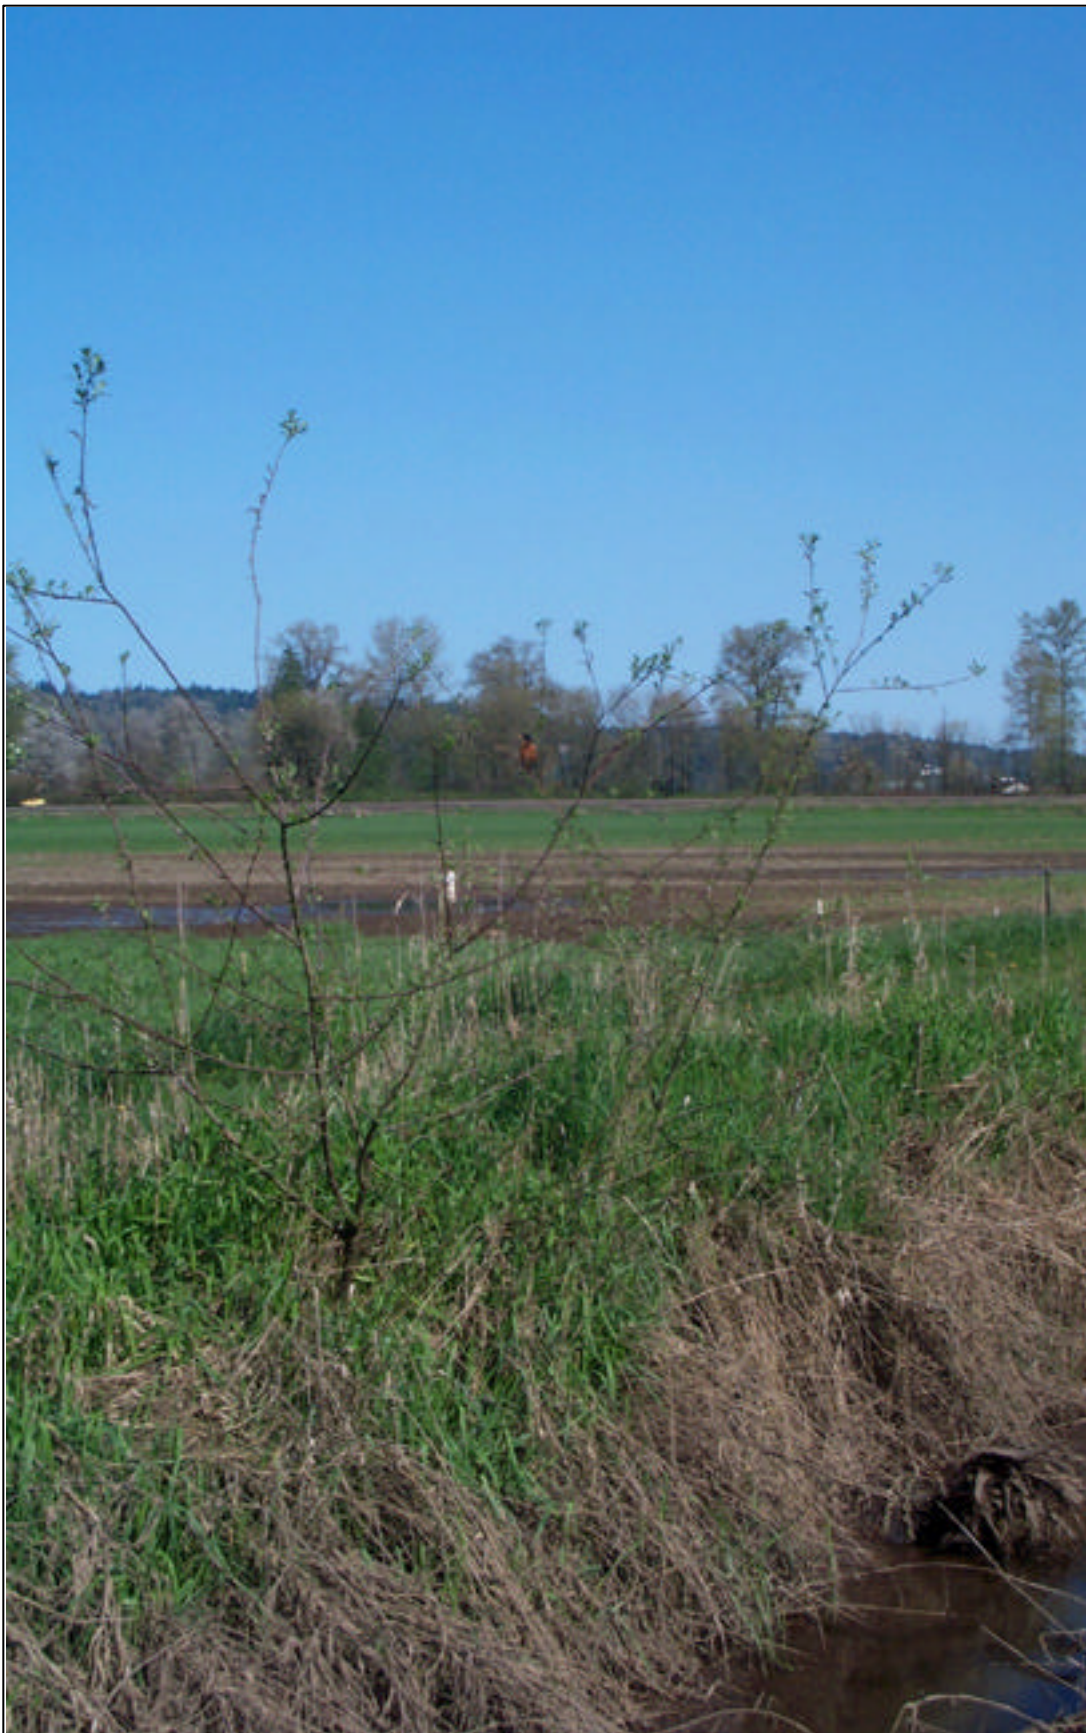
CHERRY VALLEY TRIBUTARY MITIGATION VEGETATION, SPRING 2001
